Subject: MIL ILLUMINATION WITH DTC P2135	Bulletin No: 01-016/06
	Last Issued: 05/18/2006

2003 - 2005 Mazda6 3.0L

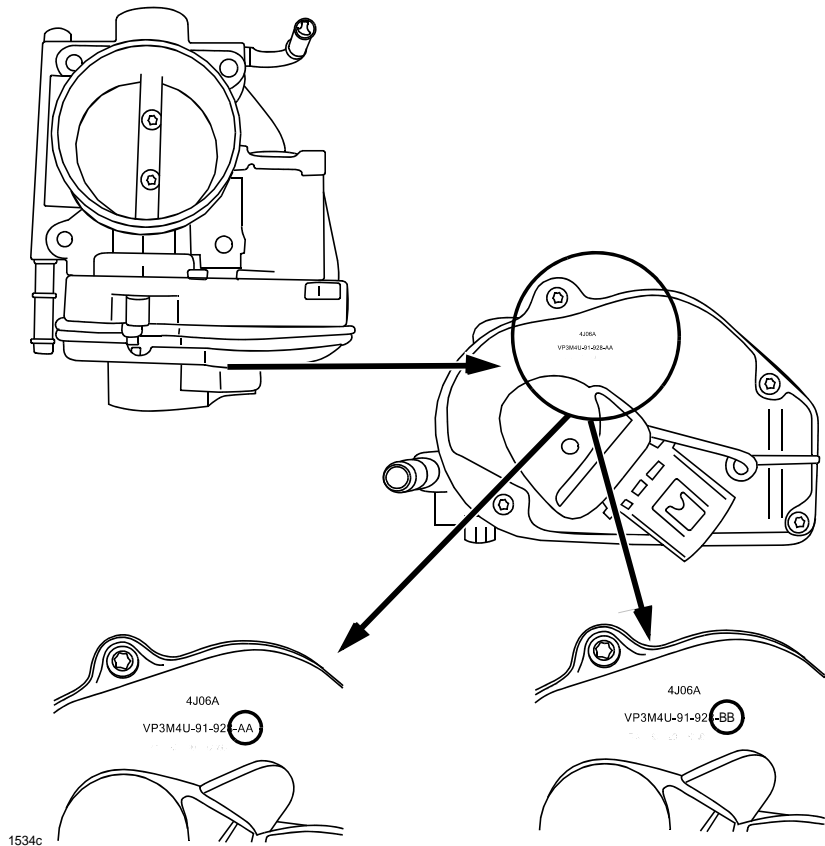
THROTTLE BODY

AA, AB, BA MARKINGS = NO GOOD BB MARKING = GOOD

- If letters "AA", "AB", or "BA" are found on the throttle body, proceed to Step 4.
 - If letters "BB" is found on the throttle body, troubleshoot DTC according to the Workshop Manual.
4. Record customer's preset radio stations.
 5. Disconnect negative battery cable.
 6. Replace throttle body according to Workshop Manual (section 01-13 INTAKE AIR SYSTEM REMOVAL/ INSTALLATION [AJ]).
 7. Reconnect negative battery cable.
 8. Erase DTC.
 9. Re-enter customer's preset radio stations.
 10. Verify repair.
